Hikurangi Catchment Freshwater Monitoring Programme 2017 – Baseline Survey

Hikurangi Catchment Freshwater Monitoring Programme - 2017 Baseline Survey

Amy Bazeley - AB Ecology Ltd - **April 2017**

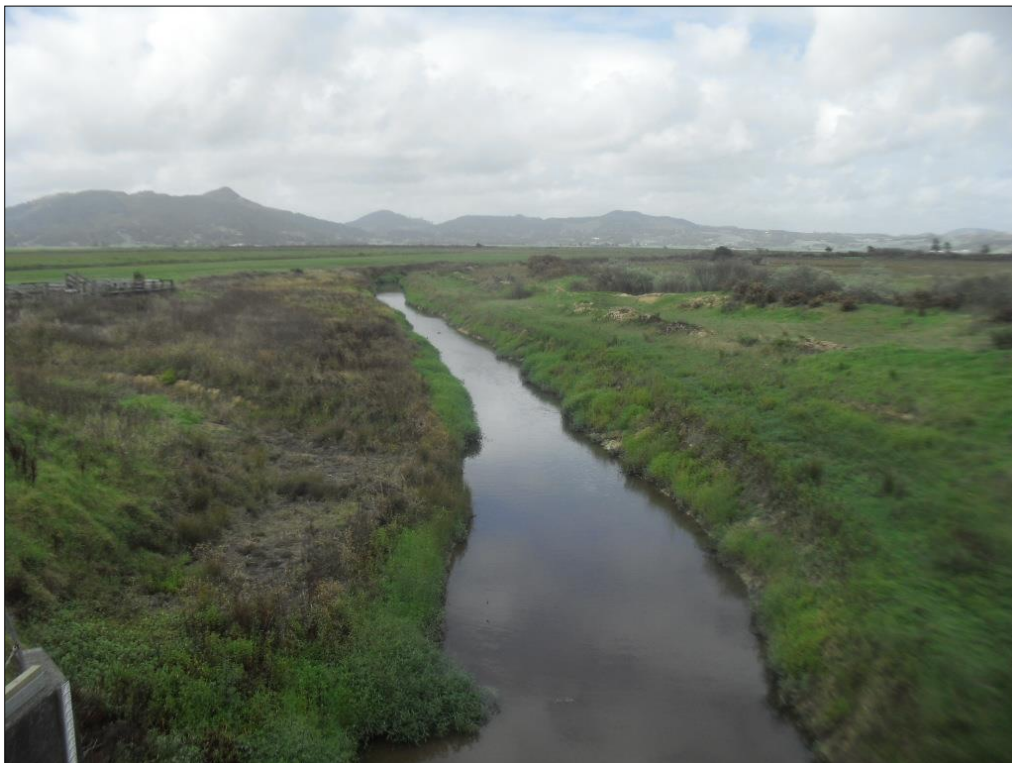
Site photo:

The stream is soft-bottomed and dominated by bare clay. There is a layer of loose sediment on the substrate and on most instream features. There was no instream woody debris, moss or leaves.

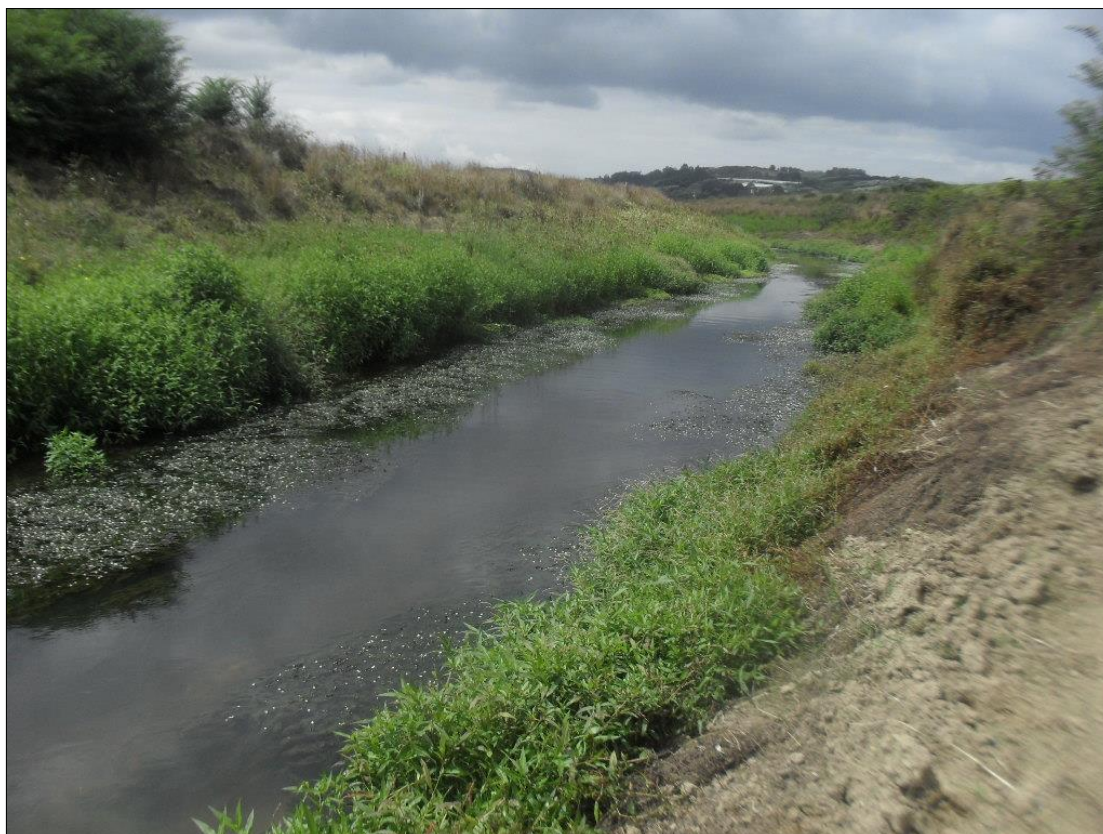
Site photo:

Site 2 has been channelised but is still weakly sinuous. The channel is approximately 4 metres wide and is one long run. Flows levels were low at the time of survey. The flow rate was moderately slow but at least noticeable, which is different to the sluggish flows observed at many of the other pump station sites. The banks are steep, stable and straight and the upper bank height is 4 metres tall. There is a lower terrace on the true left bank which is around 1 metre tall. The riparian vegetation is mainly rank grass, bare earth, or weeds and sedges. There is the occasional tree and shrub including tree privet, grey willow and manuka. Blackberry was also recorded. The bank vegetation does not offer any effective shade to the waterway.

The stream is soft-bottomed and dominated by clay and mud. However, there are areas of accumulated sand and fine gravel, which were visible in open areas between the beds of *Egeria*. Where this coarser substrate occurred, a thin layer of loose sediment was common across the substrate base. There were no instream woody debris, moss or leaves recorded.

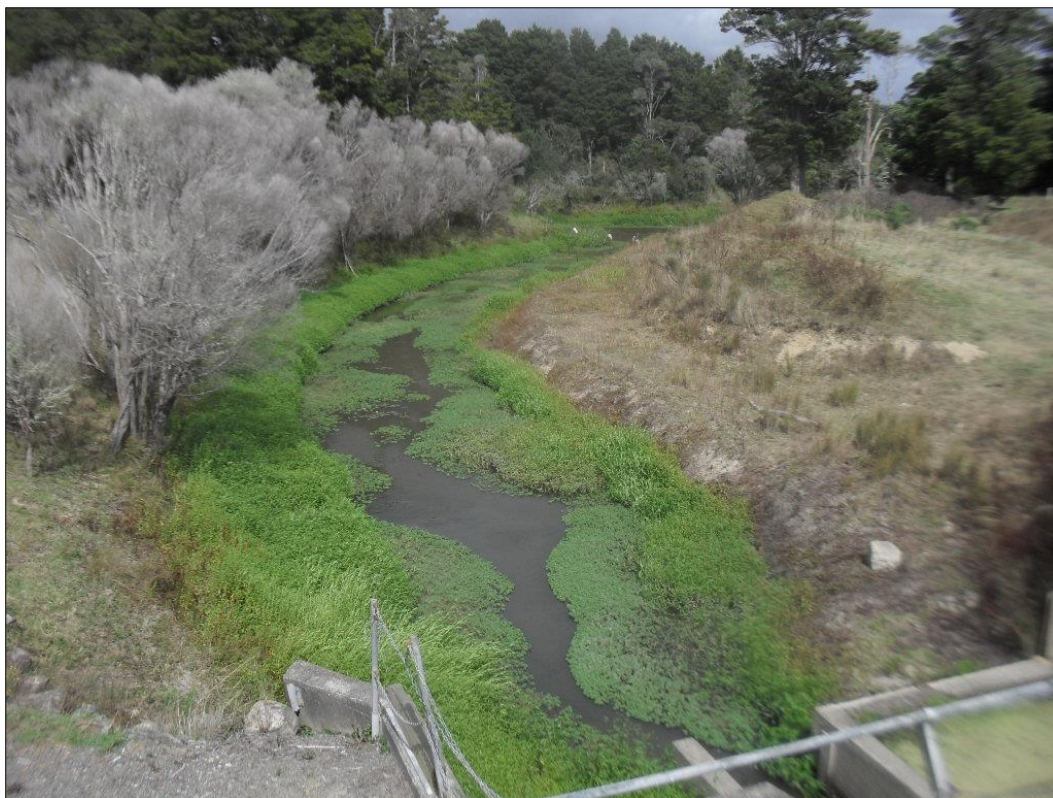
Site photo:

This is a pump station tributary site. Forsythe Stream flows into the north-eastern end of the swamp from the farmed hills around Riponui. A number of drains from dairy land in the north-eastern corner of the swamp also flow into Forsythe stream upstream of the survey site. The survey site is immediately upstream of the pump station. Forsythe Stream confluent with the Wairua river 50 metres downstream of the site.

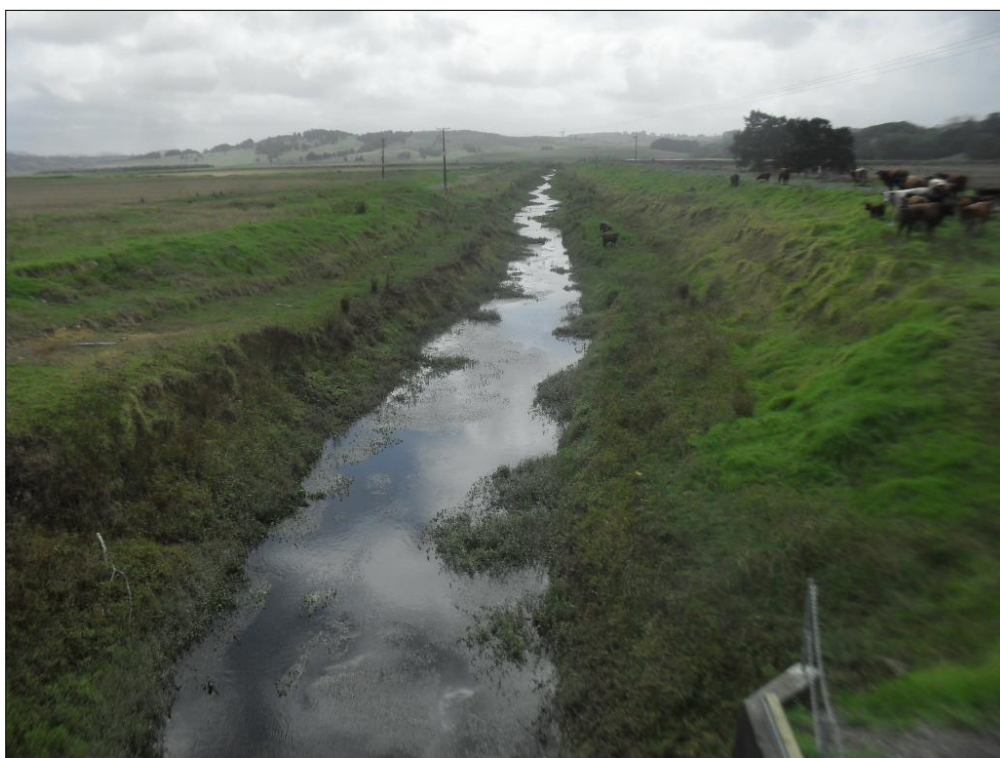
Site photo:

The stream is soft-bottomed and dominated by hard-packed clay. There were some areas of sand and silt and a 20cm layer of sediment settled over the clay base. There was no instream woody debris, moss or fallen leaves.

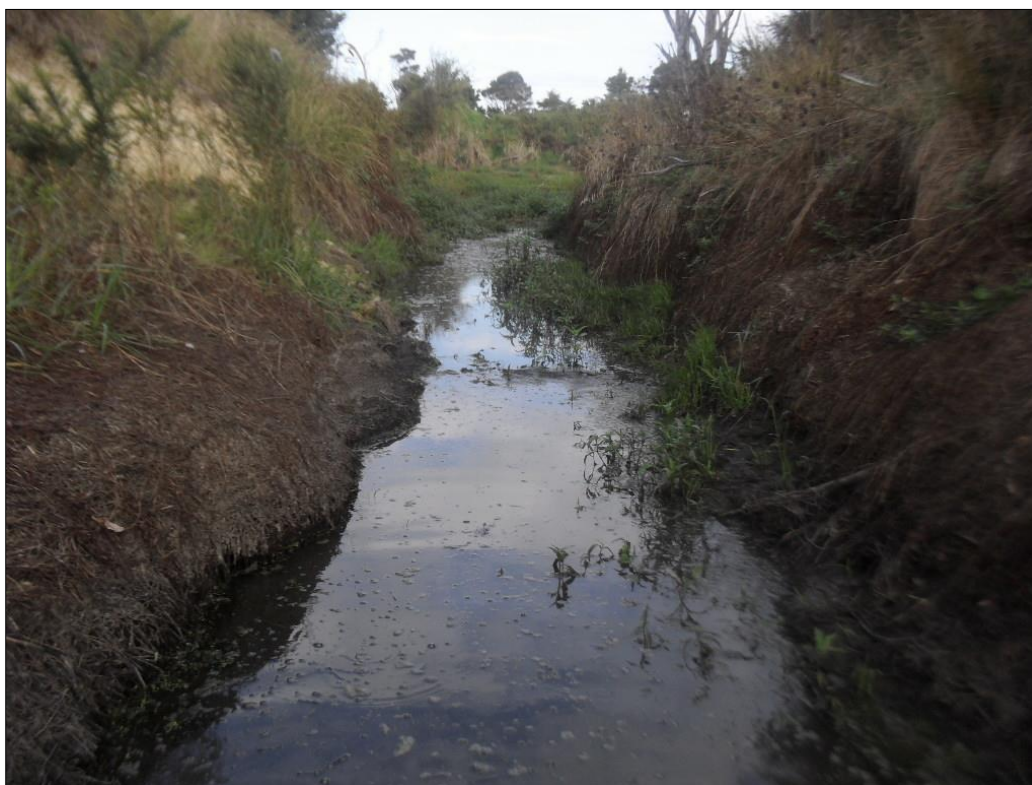
Site photo:

The surrounding land use is dairy grazing land. There is no evidence of stock damage. The drain is fenced but also too steep for stock access.

Aquatic plants were present at this site but not abundant (2 to 15% total cover). The emergent plant, water pepper had recently been sprayed along the lower edges of the banks. Other species present were also emergent and included duckweed, alligator weed and the sedge species *Cyperus brevifolius*. The water clarity was moderate but there was a layer (approx. 10cm thick) of loose sediments over the substrate which meant clarity was quickly lost on disturbance. Long, green filamentous algae was common growing on the stems of the instream vegetation. Surface scums were common.

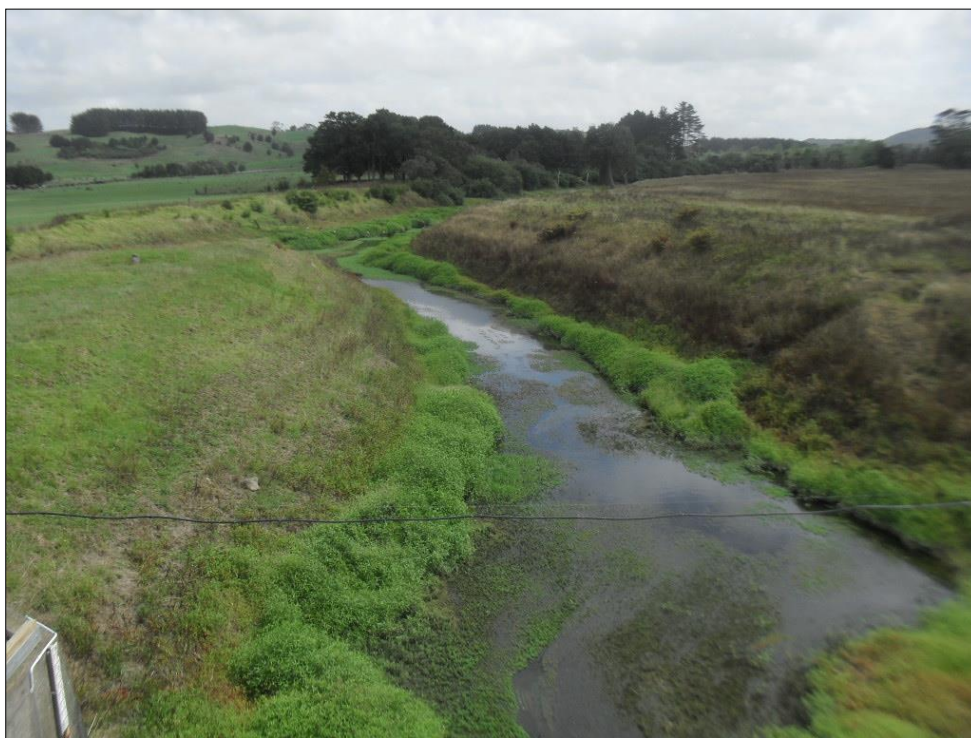
Site photo:

This is a pump station tributary site. Okarika Stream drains the central western part of the swamp from the area around Riponui and Otakairangi. The majority of the catchment is dairy land but this drain also receives flow from the Otakairangi swamp. Site 6 is just upstream of the confluence of this major tributary and the Wairua River. The site is immediately upstream of the pump station.

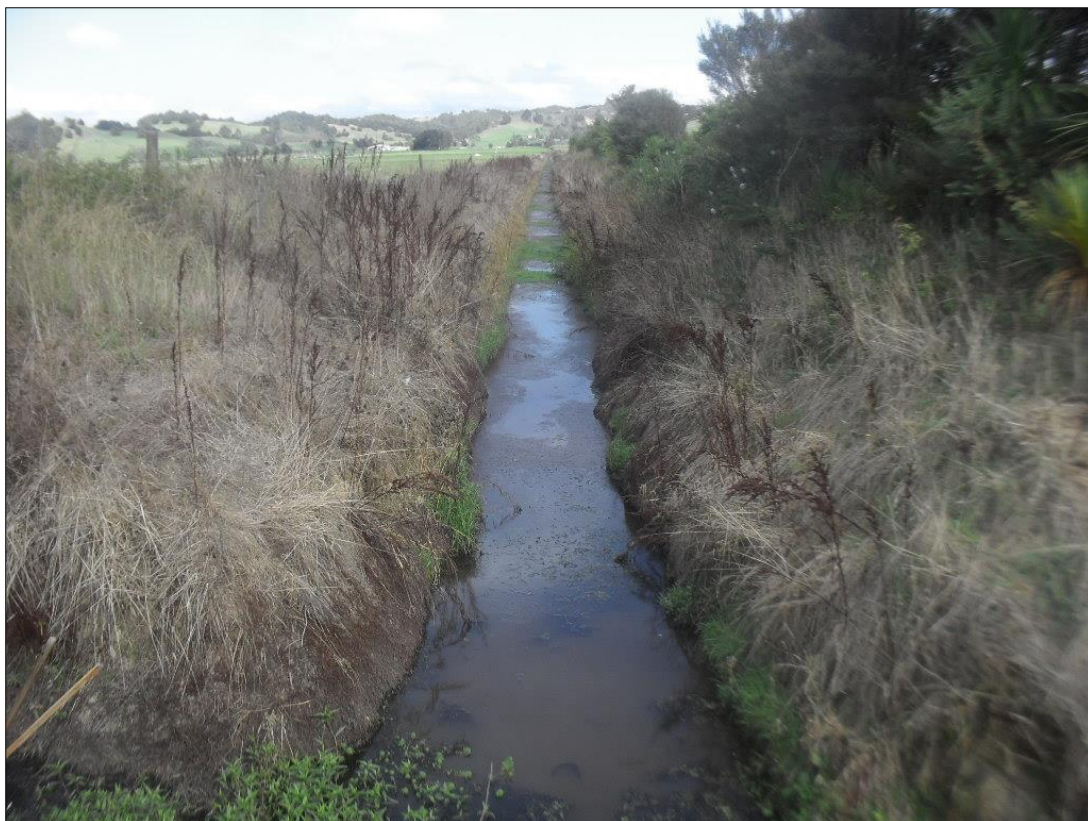
Site photo:

The surrounding land use is dairy grazing land. There is no evidence of stock damage. The drain is too steep for stock access.

Aquatic plants provide almost continuous cover in the channel and are around 60 to 100% cover. There are thick beds of the submerged species *Egeria densa* throughout the site. Emergent and floating species include abundant parrots feather and duckweed. The sedge species *Cyperus eragrostis* is present at the banks edges. The water clarity was low and there is a layer (approx. 15 to 20cm thick) of loose, anaerobic sediments over the substrate. Long, green filamentous algae was common growing on the stems of the instream vegetation. There were light brown and green mats of algae floating in the water column and on the surface of the water. Surface scums were common.

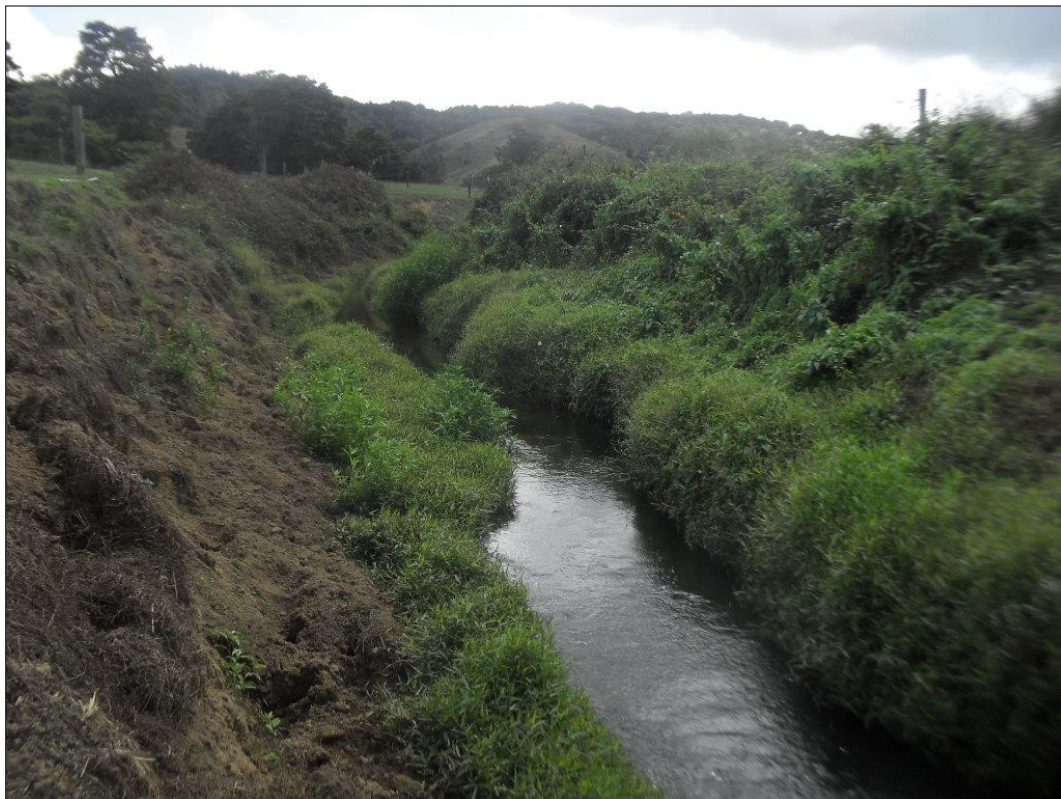
Site photo:

The stream is soft-bottomed and dominated by clay and mud but with beds of sand and gravel. Where this coarser substrate occurred, a thin layer of loose sediment was common across the substrate base ranging from 5 to 30% cover. There was the occasional instream woody debris, but no leaves or moss. The occasional freshwater mussel was recorded at this site with the bathyscope and three Crans bullies were also recorded.

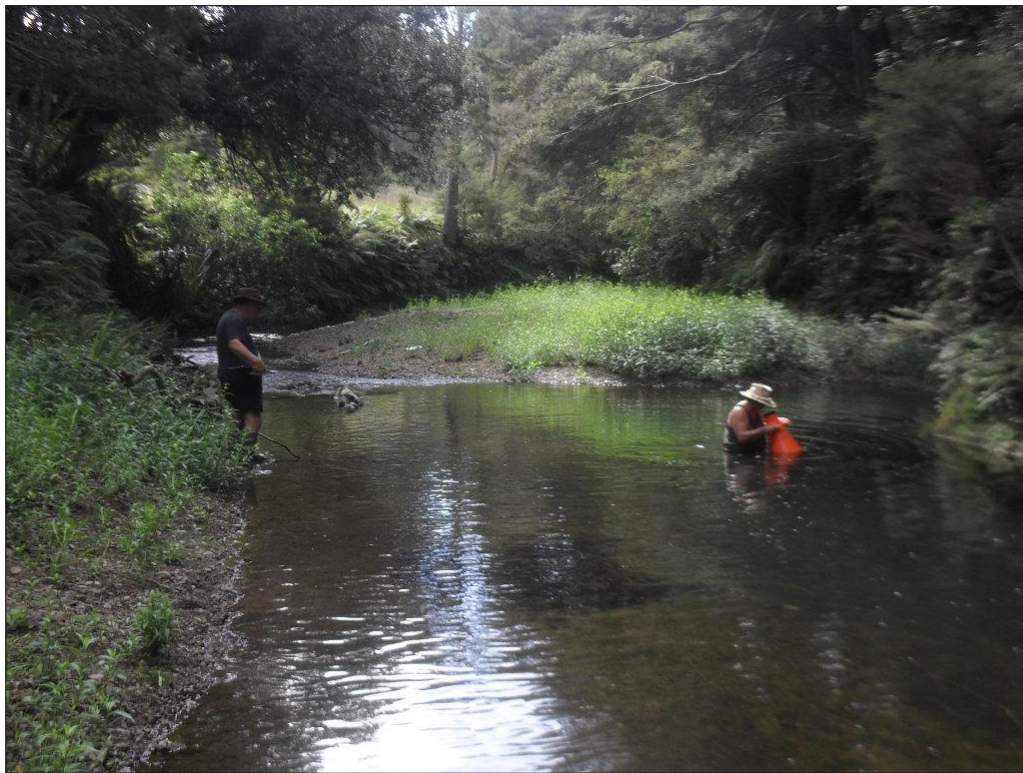
Site photo:

The Kaimamaku Stream is an upper floodplain site, which is one of the main tributaries to the Whakapara River. It flows through the farmed valley that Russell Road winds through, and its catchment is largely higher, steep ground that is in forestry or native bush.

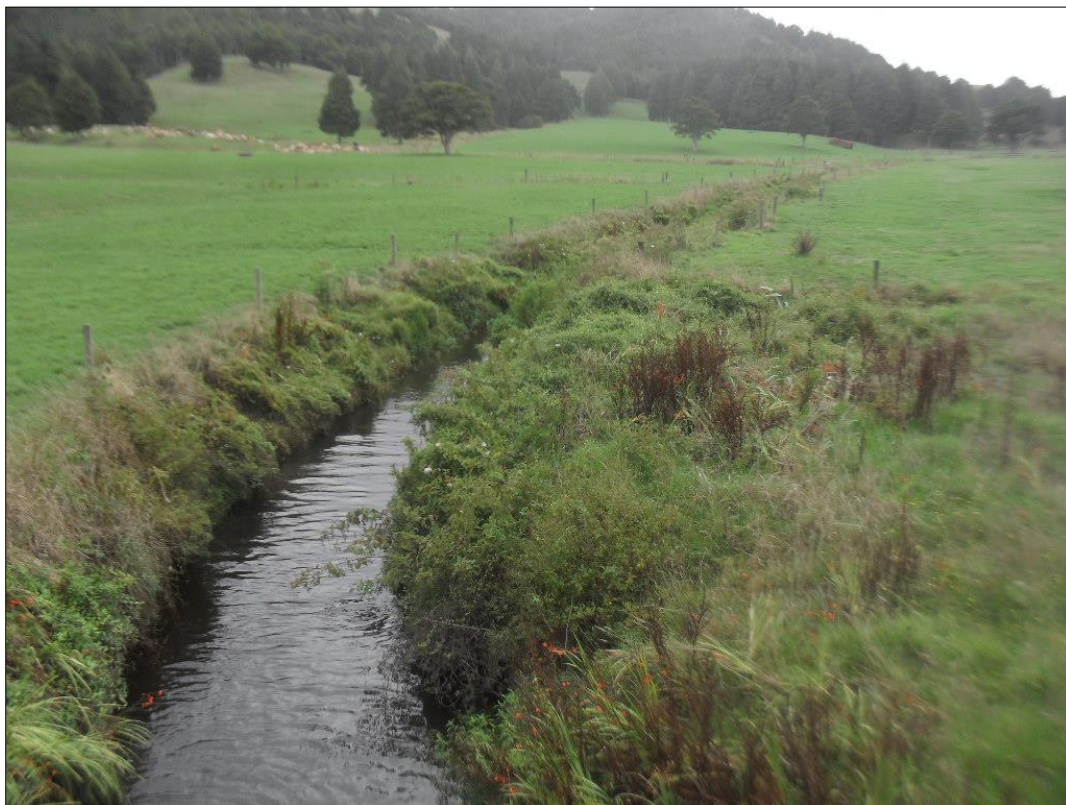
Site photo:

The immediate surrounding land use is dairy grazing land. Beyond this is bush clad hills. There is no evidence of stock damage. The drain is too steep for stock access and is fenced.

Aquatic plants were common in the channel and much of the survey area had almost complete channel cover from *Nitella* sp. and red pondweed. Water pepper dominated in the survey area at its upstream end. The water clarity was moderate but there was a layer (approx. 10cm thick) of loose sediments over the substrate which meant clarity was quickly lost on disturbance. Long, green filamentous algae was common growing on the stems of the instream vegetation.

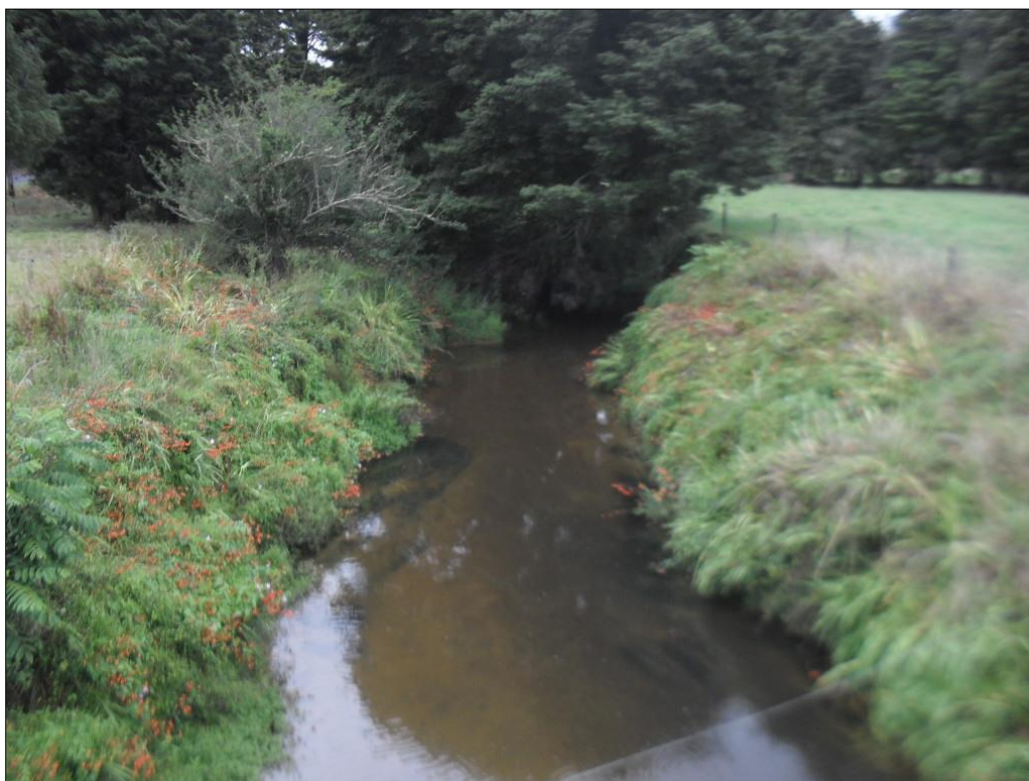
Site photo:

The immediate surrounding land use is beef grazing land. Beyond this are bush clad hills. Stock have some, restricted access to the river 50 metres upstream of the site, at a fenced off drinking point. There is no evidence of stock access or damage to the river banks or bed in the surveyed reach.

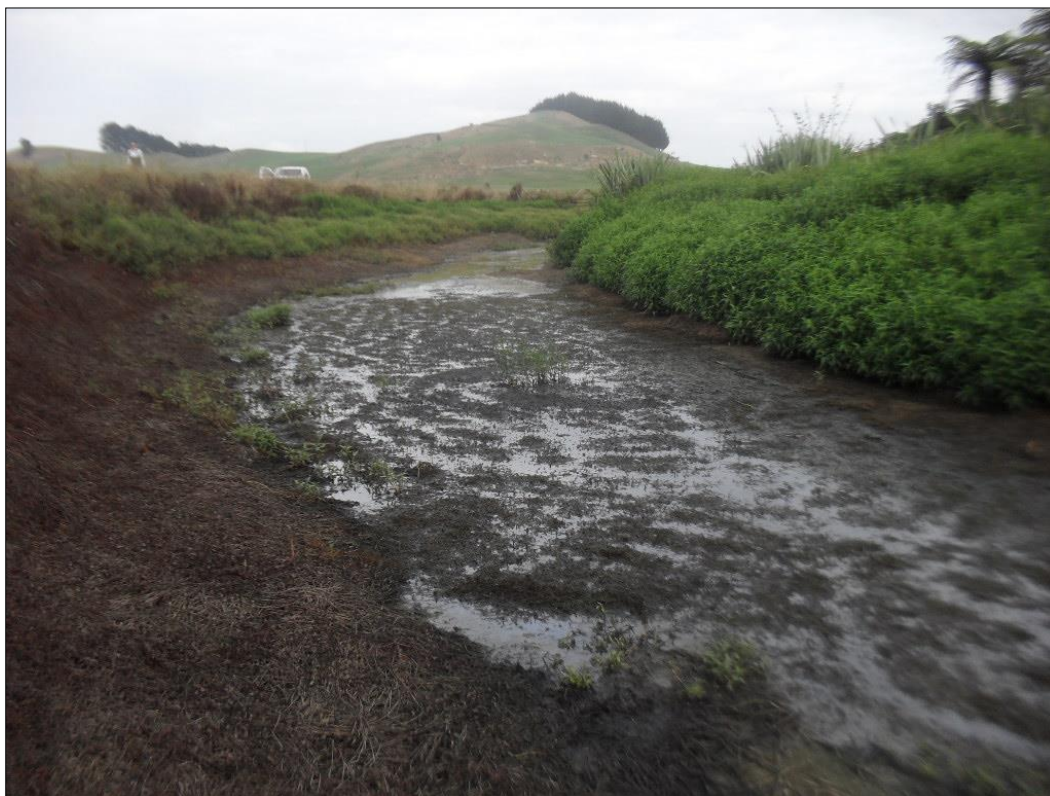
Site photo:

Aquatic plants were a dominant feature of this site with thick beds of *Egeria densa* covering most of the channel. Water pepper was also common at the stream edges. Duckweed was recorded at low levels. The aquatic vegetation had been recently sprayed. This dead and decaying biomass, coupled with the low water levels at the time of survey, had led to very poor water quality with extreme levels of anaerobic sediment, low water clarity, high anaerobic odour, surface scums and oily sheens. Long and short filamentous green algae was growing abundantly throughout the site on the plant stems. Thin mats of algae were also recorded growing over dead plant matter.

Two freshwater crabs were also recorded at the traps at this site. The habitat conditions and water quality are very poor at this site under summer time low flows. The limited fish fauna recorded here may be a reflection of this.

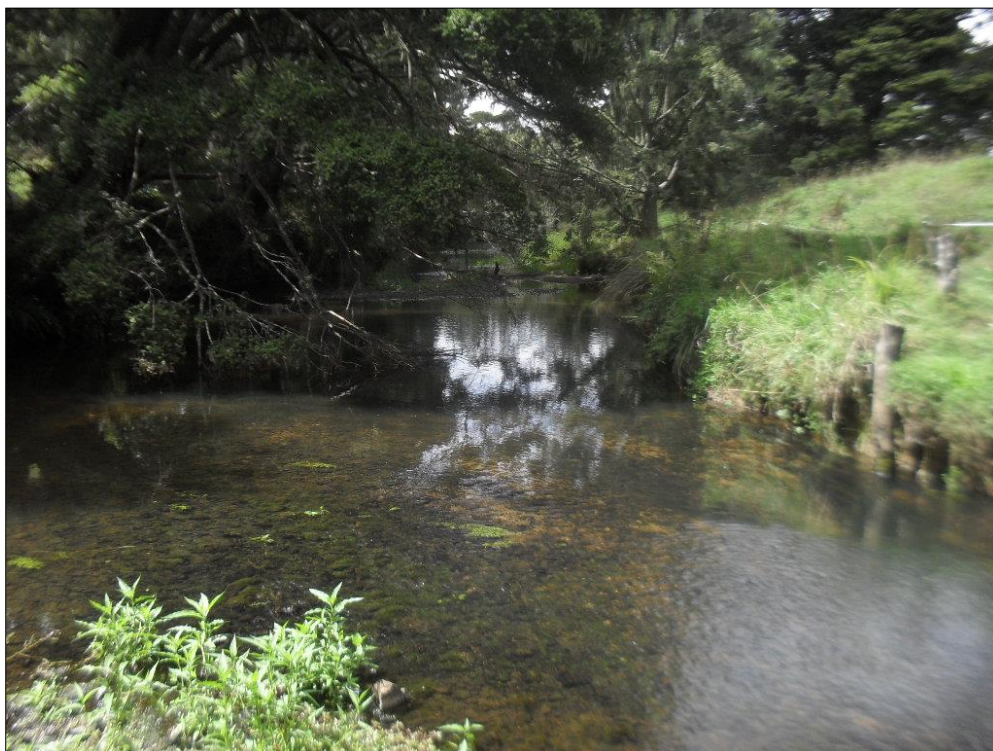
Site photo:

The immediate surrounding land use is beef grazing land. Beyond this are bush clad hills. There is some evidence of stock in the stream with minor damage at the crossing.

The stream is hard-bottomed and dominated by gravel with silt, sand and cobble. There were some large and small pieces of woody debris instream along with leaf litter and pockets of moss along the banks. Undercut banks provide habitat too. Sediment cover was common. There was a moderate layer of sediment on many of the instream sample areas observed by the bathyscope.

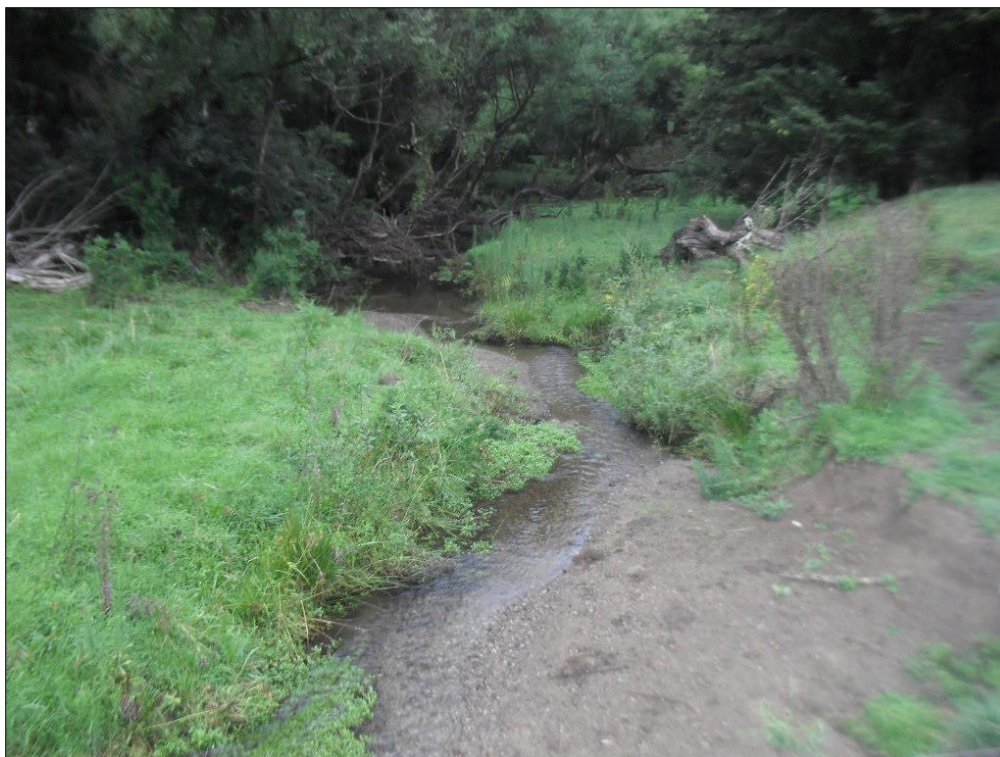
Site photo:

This site is in the upper Hikurangi Catchment. Ngaruawahine Stream drains the hilly bush and farmland in a catchment to the east of Akerama Road. It is a tributary, ultimately to the Waioitu River and confluences with it at Waioitu.

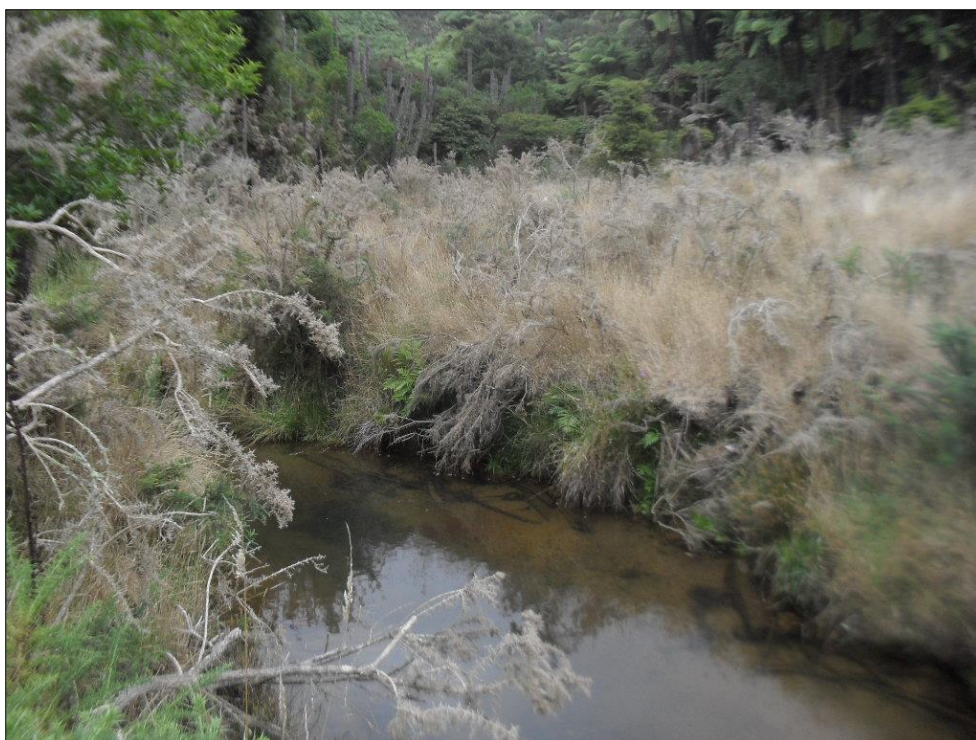
Site photo:

This site is a headwater reference site for the Waiariki River. This tributary stream is named Pukekaikiore Stream and has a steep catchment in a mix of forestry vegetation and native bush.
